Front Brake Squeal Noise

Some 2024 – 2026 model year Land Cruiser, and 2025 – 2026 model year 4Runner and 4Runner Hybrid vehicles may exhibit a condition where the front brakes produce a squealing noise when driving in reverse. Follow the Repair Procedure in this bulletin to reduce the possibility of this condition.

Repair Procedure 1 – Land Cruiser, 4WD 4Runner, and 4WD 4Runner HV

Repair Procedure 2 – 2WD 4Runner

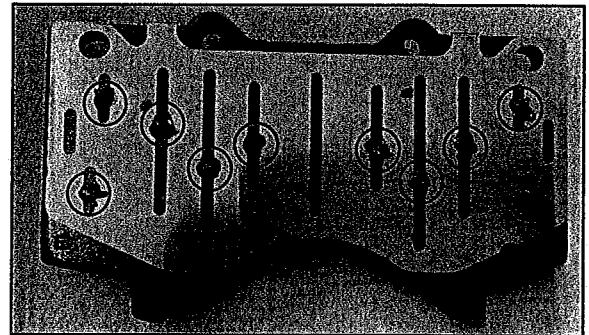
Figure 1. Shim Plate on the Back of the Brake Pad

○ Locations of Grease Application

3. Assemble the brake pad and shim kit.
 - A. Place the shim plate on the back of the brake pad, as shown in Figure 1.
 - B. Apply grease ONLY to the 10 locations, as shown in Figure 1.

- C. After applying grease, carefully place the solid shim on top.

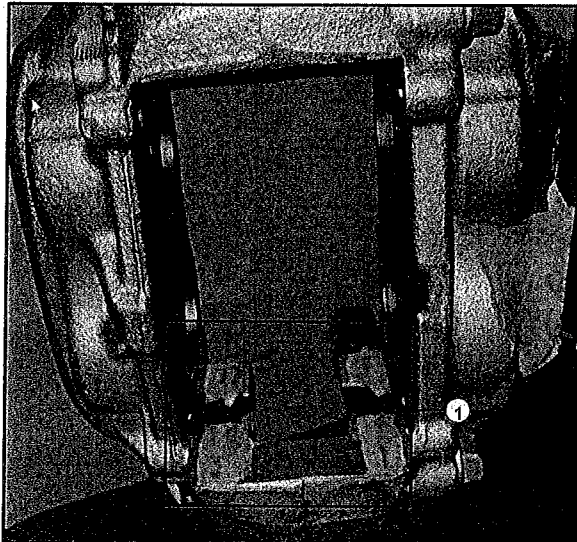
Figure 2.

1 Area of Grease Application

4. Apply brake caliper grease to the cylinder (caliper) areas, as shown in Figures 2 and 3.

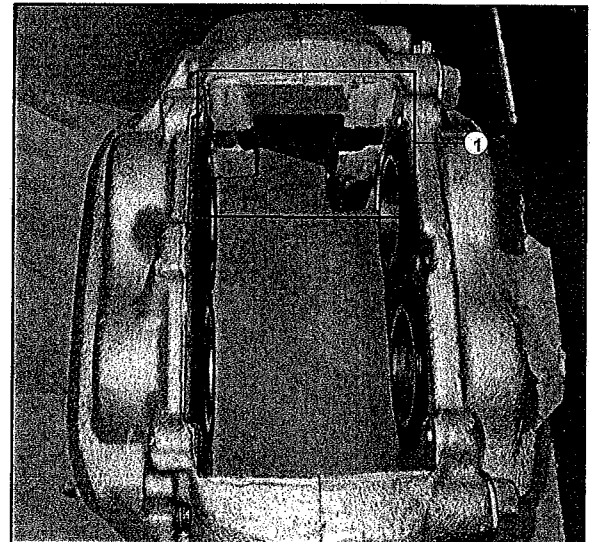
Figure 3.

1 Area of Grease Application

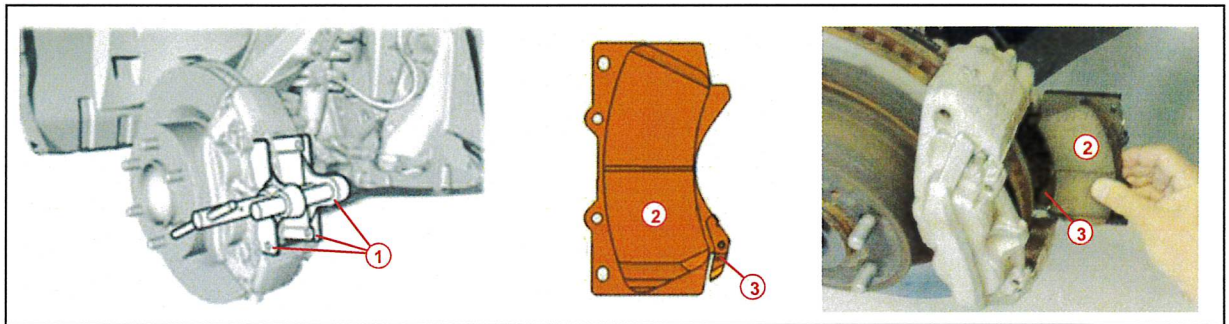
Figure 4. Brake Pad Installation

1	Disc Brake Piston Spreader Wide Type
2	Brake Pad with Wear Indicator
3	Wear Indicator

Using the disc brake piston spreader wide type, push back the front disc brake pistons, and install the brake pad with the wear indicator and shims inside the caliper, as shown in Figure 4. Ensure the brake pads orientation match the images in Figures 5 and 6.

The brake pad with the wear indicator is the inner pad and the brake pad without the wear indicator is the outer pad.

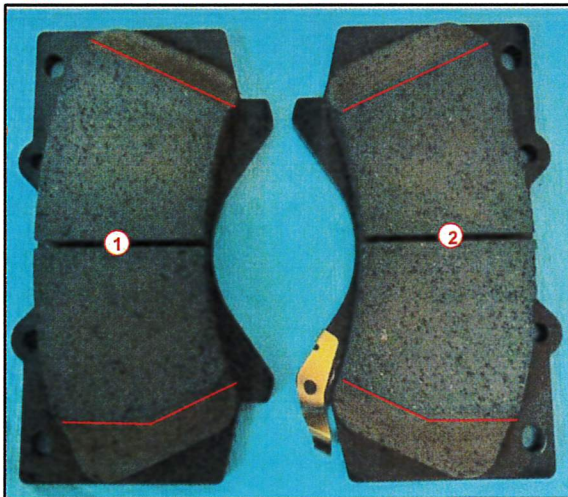
Figure 5. Left Front Brake Pad

1	Outer Brake Pad
2	Inner Brake Pad

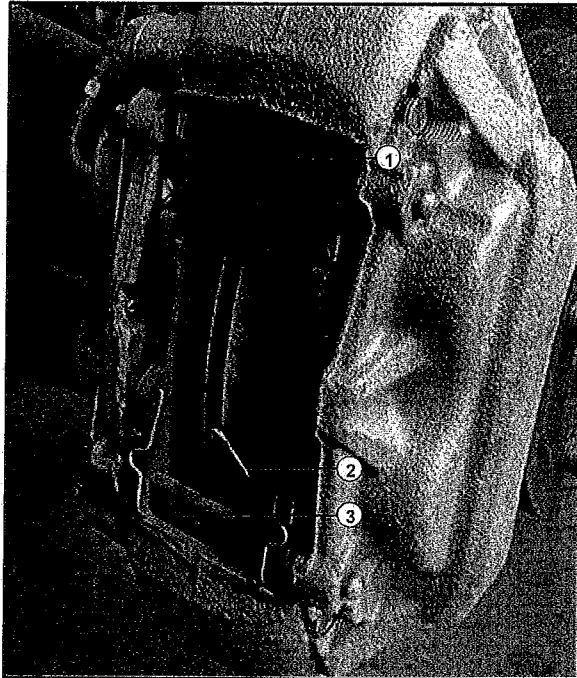
1	Front Disc Brake Anti-rattle Pin (Upper Side)
2	New Brake Anti-rattle Spring
3	Front Disc Brake Anti-rattle Pin (Lower Side)

- 6. Install the anti-rattle kit.
 - A. Install the front disc brake anti-rattle pin with the hole (upper side).
 - B. Install the NEW brake anti-rattle spring, then install the front disc brake anti-rattle pin with the hole (lower side), as shown in Figure 7.
 - C. Install the pin hold clip to the front disc brake anti-rattle pin with the hole and engage the hook to the disc brake cylinder assembly, as shown in Figure 8.
 - D. Discard the OLD brake anti-rattle spring.

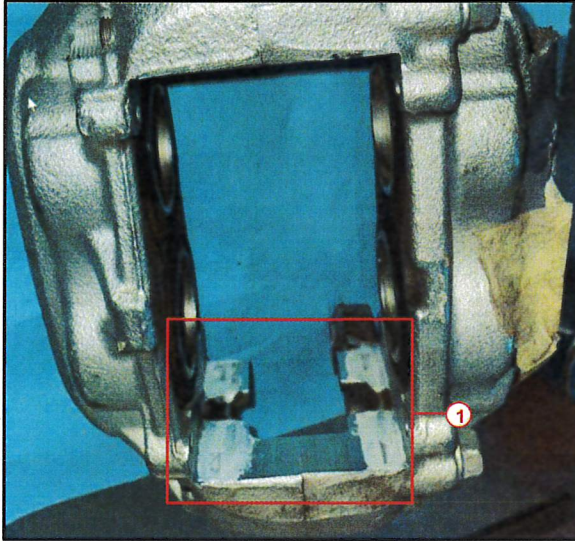
Figure 11.

1	Area of Grease Application
----------	-----------------------------------

5. Apply brake caliper grease to the cylinder (caliper) areas shown in Figures 11 and 12.

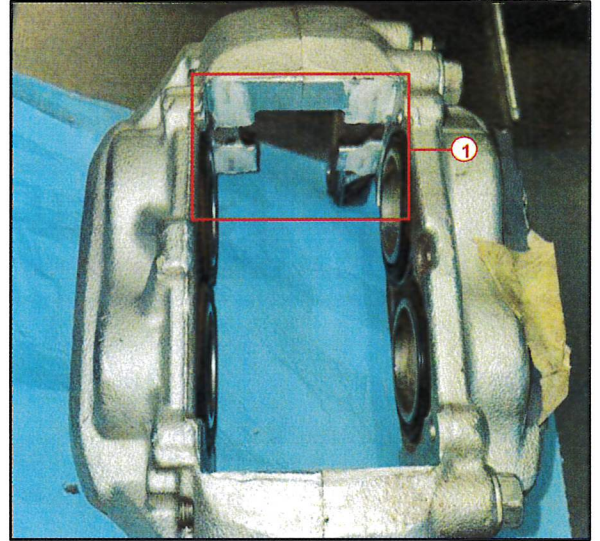
Figure 12.

1	Area of Grease Application
----------	-----------------------------------

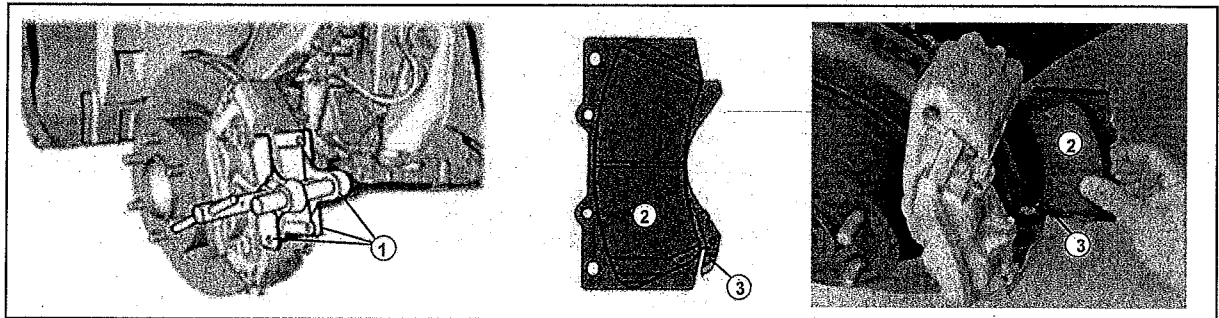
Figure 13. Brake Pad Installation

1	Disc Brake Piston Spreader Wide Type
2	Brake Pad with Wear Indicator
3	Wear Indicator

Using the disc brake piston spreader wide type, push back the front disc brake pistons, and install the brake pad with the wear indicator and shims inside the caliper, as shown in Figure 13. Ensure the brake pads orientation match the images in Figures 14 and 15.

The brake pad with the wear indicator is the inner pad and the brake pad without the wear indicator is the outer pad.

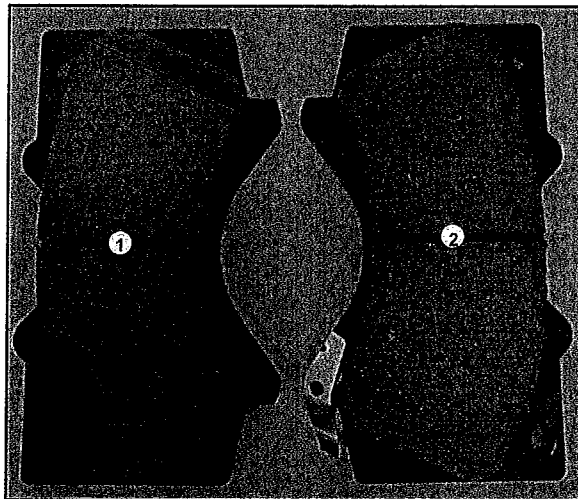
Figure 14. Left Front Brake Pad

1	Outer Brake Pad
2	Inner Brake Pad

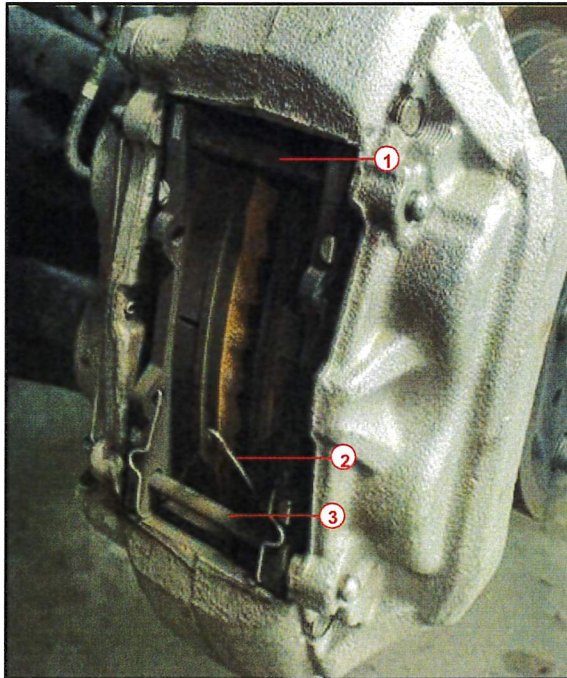
1	Front Disc Brake Anti-rattle Pin (Upper Side)
2	New Brake Anti-rattle Spring
3	Front Disc Brake Anti-rattle Pin (Lower Side)

7. Install the anti-rattle kit.
 - A. Install the front disc brake anti-rattle pin with the hole (upper side).
 - B. Install the NEW brake anti-rattle spring, then install the front disc brake anti-rattle pin with the hole (lower side) as shown in Figure 16.
 - C. Install the pin hold clip to the front disc brake anti-rattle pin with the hole and engage the hook to the disc brake cylinder assembly as shown in Figure 17.
 - D. Discard the OLD brake anti-rattle spring.

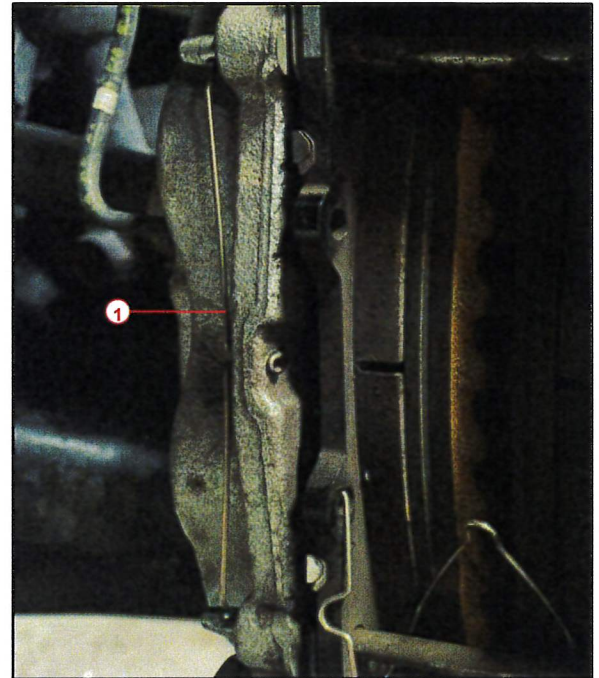
Figure 17.

1	Pin Hold Clip
----------	----------------------
