Front Brake Squeal Noise

Service Category Brake

Section Brake (front)

Some 2024 – 2026 model year Land Cruiser, and 2025 – 2026 model year 4Runner and 4Runner Hybrid vehicles may exhibit a condition where the front brakes produce a squealing noise when driving in reverse. Follow the Repair Procedure in this bulletin to reduce the possibility of this condition.

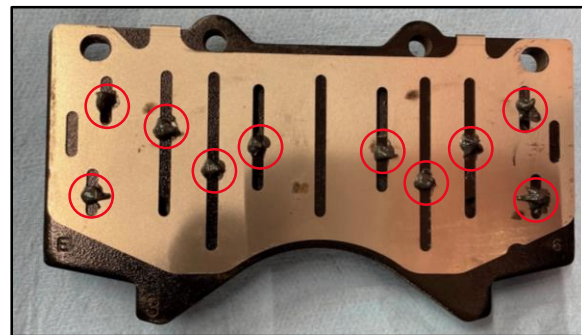
Figure 1. Shim Plate on the Back of the Brake Pad

Locations of Grease Application

3. Assemble the brake pad and shim kit.
 - A. Place the shim plate on the back of the brake pad, as shown in Figure 1.
 - B. Apply grease ONLY to the 10 locations, as shown in Figure 1.

- C. After applying grease, carefully place the solid shim on top.

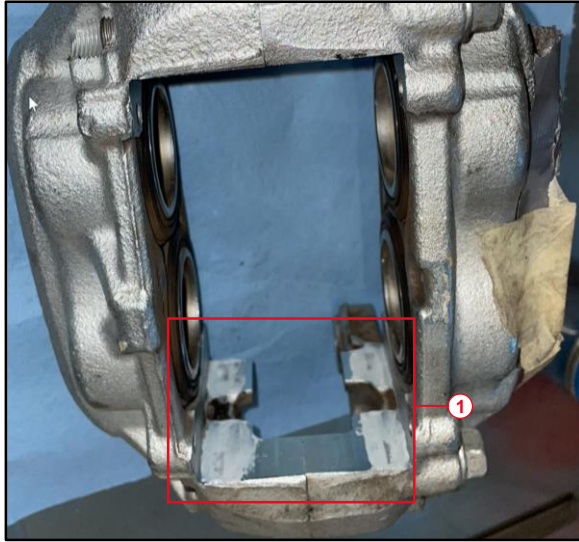
Figure 2.

1	Area of Grease Application
----------	-----------------------------------

4. Apply brake caliper grease to the cylinder (caliper) areas, as shown in Figures 2 and 3.

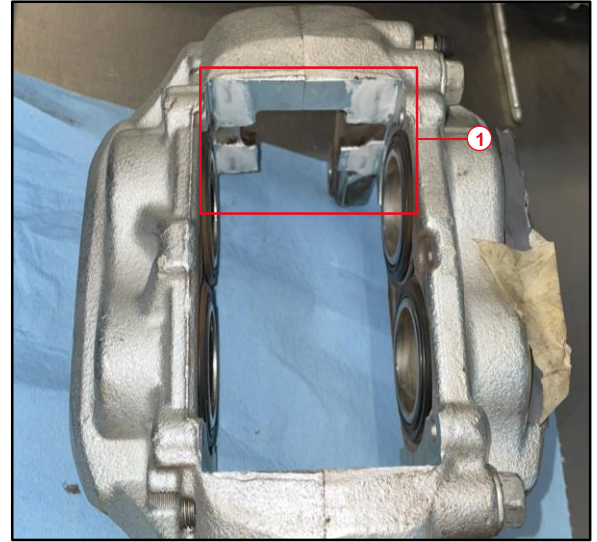
Figure 3.

1	Area of Grease Application
----------	-----------------------------------

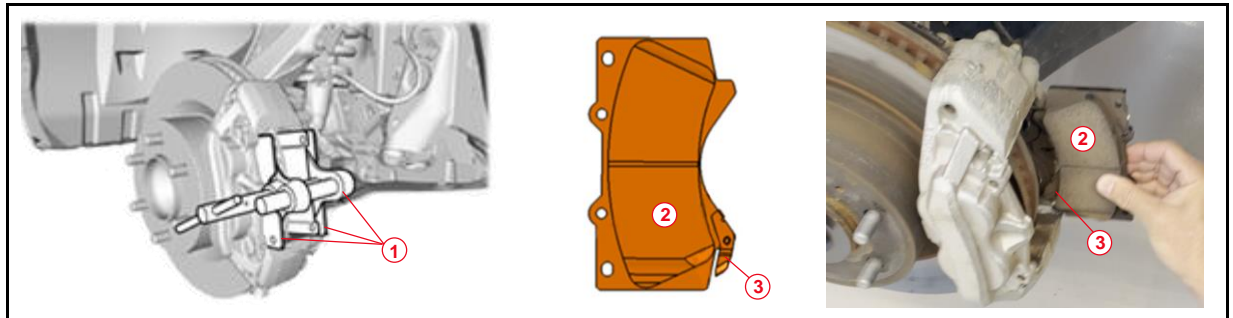
Figure 4. Brake Pad Installation

1	Disc Brake Piston Spreader Wide Type
2	Brake Pad with Wear Indicator
3	Wear Indicator

Using the disc brake piston spreader wide type, push back the front disc brake pistons, and install the brake pad with the wear indicator and shims inside the caliper, as shown in Figure 4. Ensure the brake pads orientation match the images in Figures 5 and 6.

The brake pad with the wear indicator is the inner pad and the brake pad without the wear indicator is the outer pad.

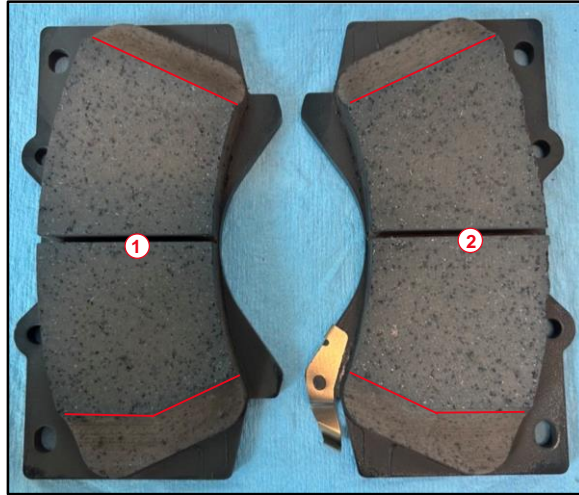
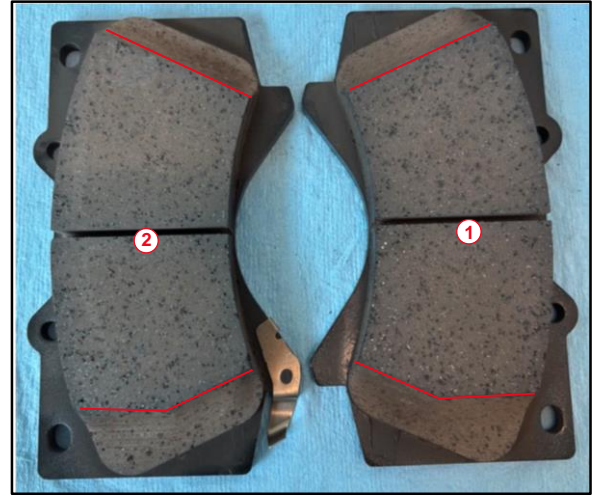
Figure 5. Left Front Brake Pad

Figure 6. Right Front Brake Pad

1	Outer Brake Pad
2	Inner Brake Pad

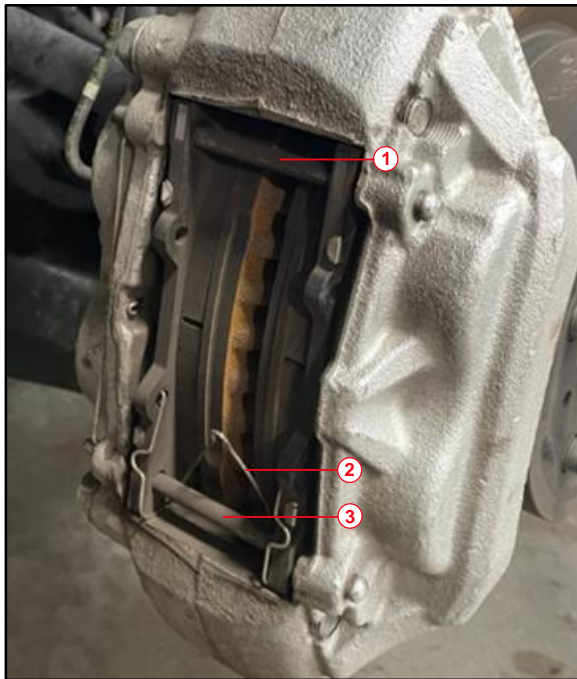
1	Front Disc Brake Anti-rattle Pin (Upper Side)
2	New Brake Anti-rattle Spring
3	Front Disc Brake Anti-rattle Pin (Lower Side)

6. Install the anti-rattle kit.
 - A. Install the front disc brake anti-rattle pin with the hole (upper side).
 - B. Install the NEW brake anti-rattle spring, then install the front disc brake anti-rattle pin with the hole (lower side), as shown in Figure 7.
 - C. Install the pin hold clip to the front disc brake anti-rattle pin with the hole and engage the hook to the disc brake cylinder assembly, as shown in Figure 8.
 - D. Discard the OLD brake anti-rattle spring.

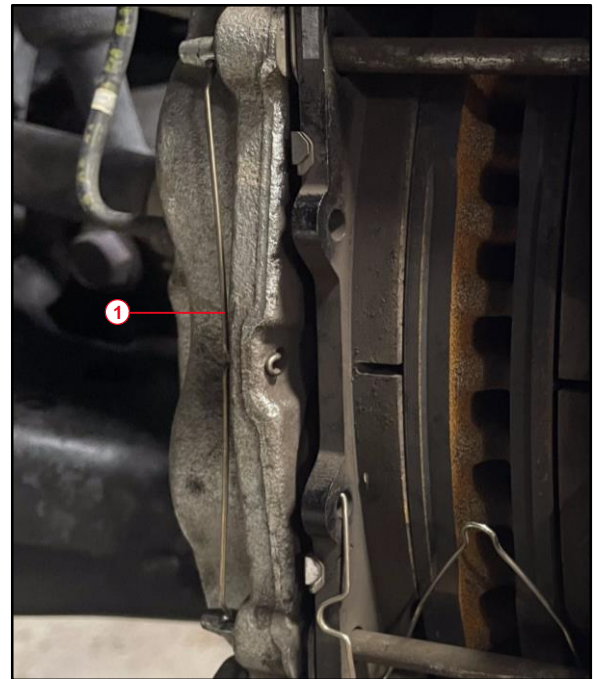
Figure 8.

1	Pin Hold Clip
----------	----------------------
